Aircraft Materials Technical Memorandum 403

EXAMINATION OF THE MICROSTRUCTURE OF 7050 ALUMINIUM ALLOY SAMPLES

Aluminium Alloy 7050 is used extensively in the F/A-18 aircraft. This report describes the results of examination of a number of samples of Aluminium Alloy 7050 which were taken from FS 488 bulkhead fatigue test specimens adjacent to the fatigue failures and from thinner material which has been used for fatigue test coupons by ARL and F/A-18 manufacturers.

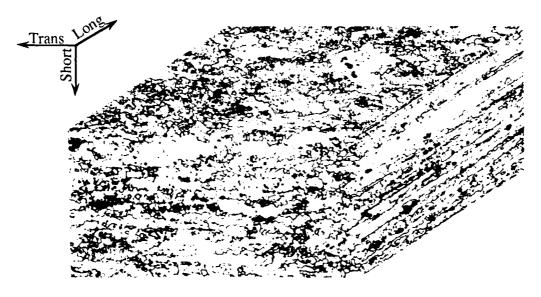
Figure 6. Manufacturer's coupon specimen 1-8A (approximately 13 mm thick) showing features similar to those of Figure 4.

Magnification: 110 Etched: Dilute Keller's 4

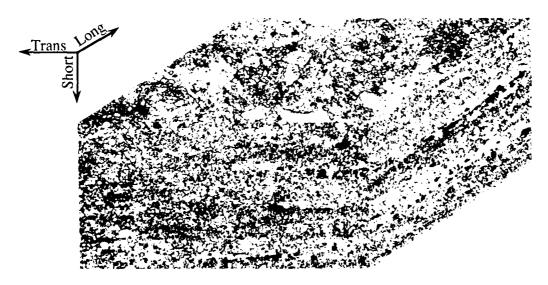
Figure 7. Manufacturer's coupon specimen A7-8 (approximately 13 mm thick) showing features similar to those of Figure 5.

Magnification: 110 Etched: Dilute Keller's 4

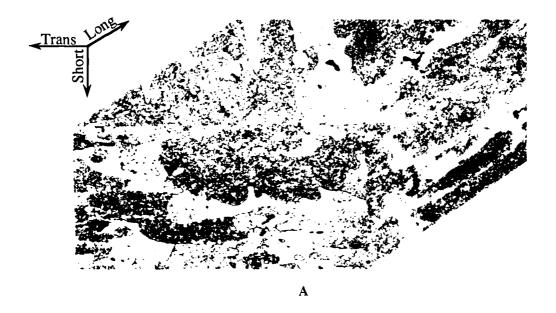
Figure 10. Porosity-containing FS488 bulkhead sample showing the limited anisotropy, although the material appears to consist of two distinct areas containing either large grains or small grains. Large precipitates are associated with the larger grains while smaller precipitates are more evenly distributed. The network of larger grains along with the placement of the larger precipitates would appear to be associated with the grain structure that existed prior to recrystallization, i.e. these regions and features appear to outline the grain boundaries of the structure prior to the solution heat-treatment and ageing cycles.

Magnification: 110 Etched: Dilute Keller's (10A), Molybdic Acid (10B).

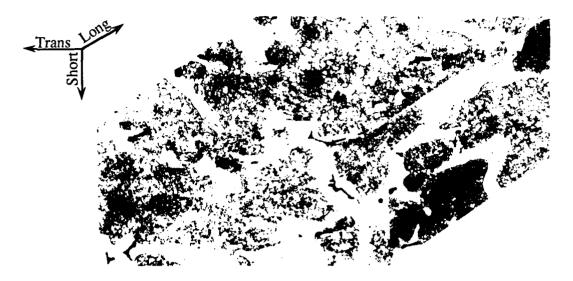
Figure 13. Sections taken from the F/A-18 FT41 FS 488 bulkhead centre plate region showing little evidence of working. The material consists of two distinct regions; large grains outlining the prior grain structure, and small grains clustered within the large grain network. Massive precipitates are associated with the larger grains while smaller precipitates are more evenly distributed.

Magnification: 110 Etched: Molybdic Acid.

- TEM examination of one of the 150 mm specimens (FT41, Figure 13) revealed that the orientation and size of the grain boundary precipitates appeared to vary according to the type of grain boundary at which they occurred. This variation has resulted in a more tortuous path for the PFZ in the small-to-small grain boundaries due to the orientation of the precipitates at these boundaries. It is likely that this would result in a difference in the fatigue and corrosion resistance between the types of grain boundaries. The difference would probably result in the small-to-small boundaries having a higher resistance to fatigue and corrosion than the large-to-large and the large-to-small grain boundaries. Evidence to support this hypothesis has been supported in initial work (as yet unpublished).

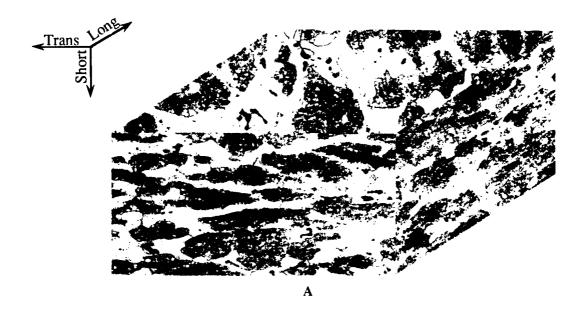
Figure 15. Material from the FS488 bulkhead fatigue-tested in Aircraft Structures Division. These micrographs show the limited anisotropy, with two distinct grain sizes. Large precipitates are associated with the larger grains while smaller precipitates are more evenly distributed. The network of larger grains along with the placement of the larger precipitates would appear to be associated with the grain structure that existed prior to recrystallization, i.e. these regions and features appear to outline the grain boundaries of the structure prior to the solution heattreatment and ageing cycles.

Magnification: 110 Etched: Dilute Keller's (10A), Molybdic Acid (10B).
